Technical Service Bulletin

3/27/02
POSTED
NUMBER: 08-001-02

Rear Window Defogger Inoperative

2001 - 2002 (JR) Sebring Convertible
1996 - 2000 (JX) Sebring Convertible

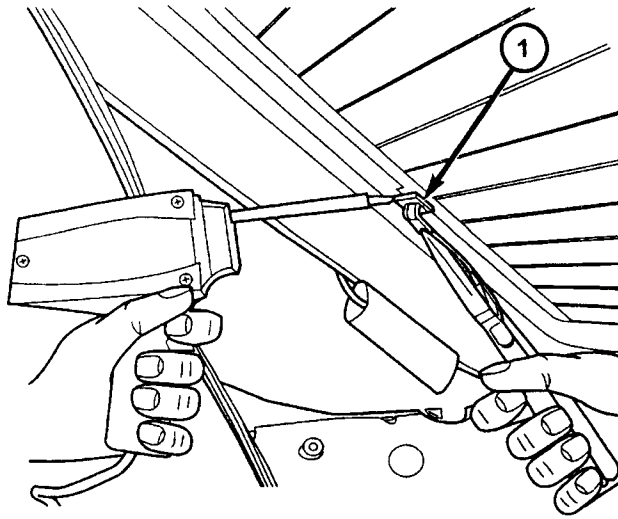
Fig. 2 CLIP REMOVAL

1 - HEAT CLIP TO REMOVE

3. If clip has come loose from the glass, skip to step 5.
4. Apply heat with a solder gun to the portion of the terminal clip on the glass until the solder starts to flow, remove the clip then smooth the solder. Wait 5 minutes for the glass to cool before proceeding, (Fig. 2).

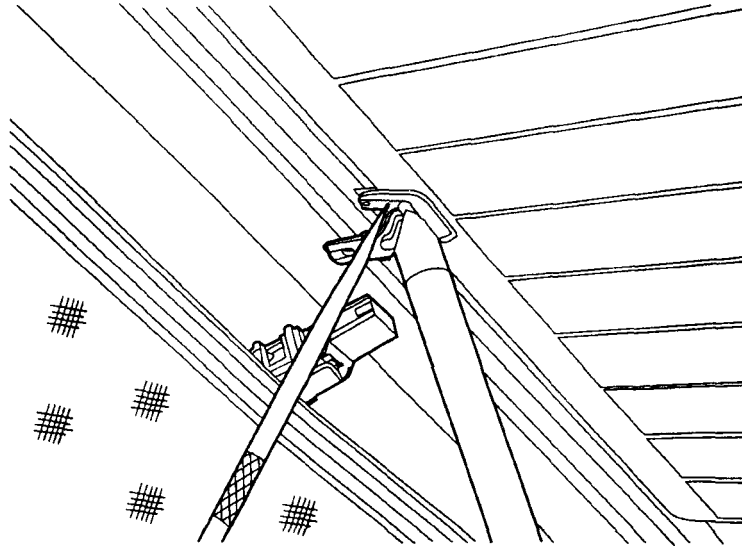
Fig. 3 CLIP ORIENTATION AND ATTACHMENT

This bulletin involves replacing and reorienting BOTH rear window defogger grid terminal clips so the tips face outboard, as necessary. Failure to reorient the terminal clips may result in an additional failure.

6. Holding the new terminal clip with a metal "pick" or other suitable pointed tool, place the new terminal clip in the same location as the original terminal clip but with the tip of clip facing outboard.

NOTE: THE TIP OF THE TERMINAL CLIP MUST FACE OUTBOARD. CLIPS ARE PRE-SOLDERED AND FLUXED. DO NOT REUSE A CLIP IF IT HAS BEEN HEATED PREVIOUSLY.

7. Place the solder gun on the new terminal clip and heat until the solder flows. Remove the solder gun and continue to hold the clip in position for 5 seconds. Let the solder area cool for 10 minutes, (Fig. 3).
